NUMBER D2-14934-6

TITLE WS-133A Maintainability Program, Final Report

MODEL NO. WS-133A CONTRACT NO. AF04(647)-289

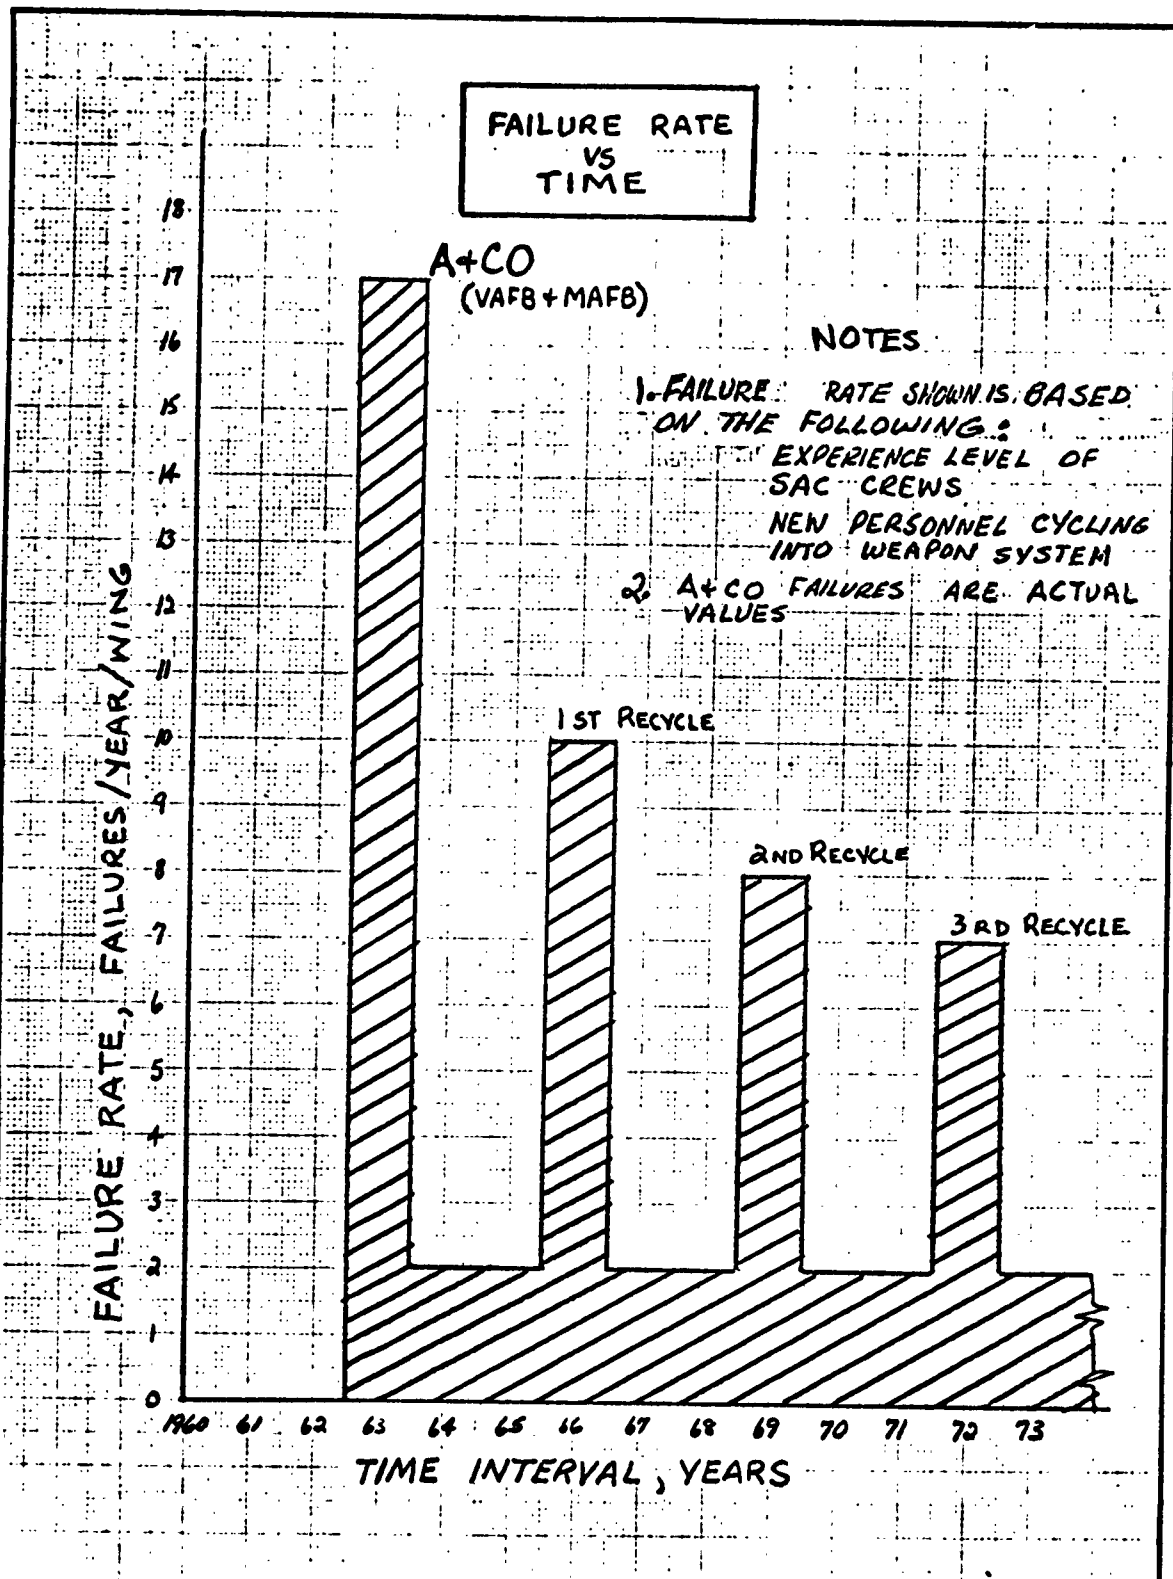
CALC			REVISED	DATE	PROJECTED FAILURE RATE LF MOTOR-GENERATOR D-C INPUT CABLE - MALMSTOM	
CHECK						
APR						
APR						
By:	Henschel	3-21-3			THE BOEING COMPANY	PAGE

- 1.) Failures due to procedure short cuts and correct procedure not being followed.

10 per AFB during A & CO (Assumed - MAFB & VAFB failures as a basis)
39 per AFB per 10 years (see attached graph) - Assumed failures

total failures (5 AF Bases)

A & CO 10 x 4 (Malmstrom won't be counted, failures have already occurred) = 40 A & CO failures.

Failure during
SAC Maintenance 39 x 5 = 195 SAC failures
Total = 235

95% can be prevented by the instruction placard .95 (235) = 223
preventable failures

Recommended Placard

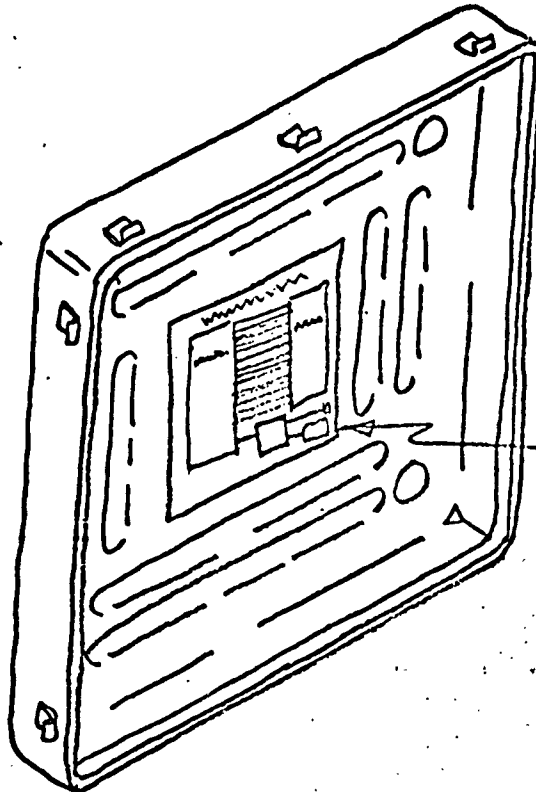
ATTACHMENT B

ADD
PLACARD SHOWING
CABLE HOOK-UP
FOR PROGRAMMER
GROUP TEST
SET SELF-TEST
(REF. T.O. 21-SM80A-23)
FIG. 2-25

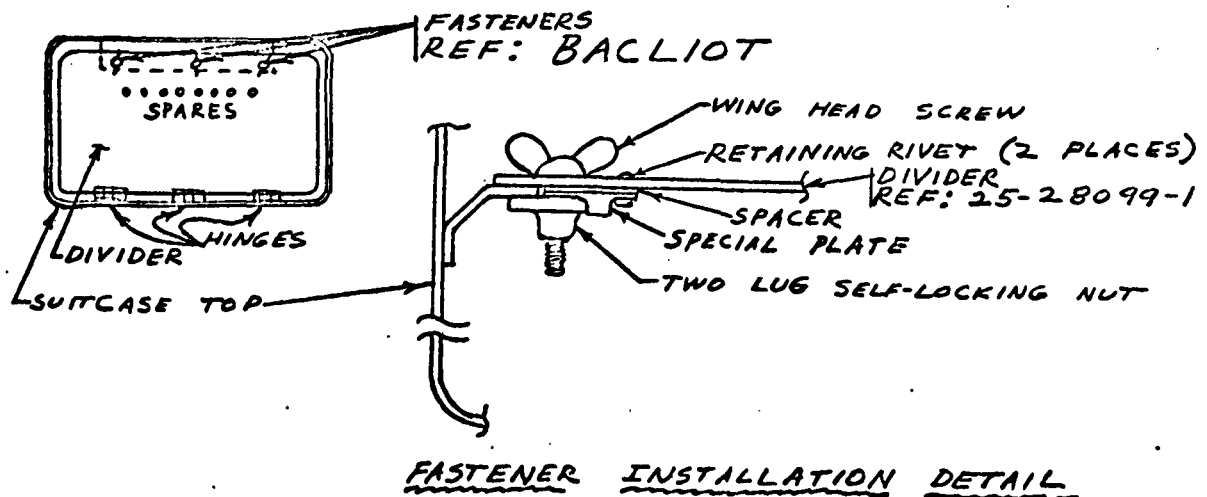
Item 15

Problem: The Launcher Simulator and other Minuteman suitcases have a hinged divider in the cover opposite the hinge, three fasteners, BACLIOT, are used. These fasteners are difficult to engage under the cover lip as the two lug self-locking nut loses its locking feature and does not rotate under the lip when the wing head screw is tightened. After tightening the wing head screw the lug nut is not under the lip. When the cover is placed on the suitcase base the cover divider swings down and breaks the spare bulbs or fuse holders mounted on the divider. This fastener problem will continue to damage equipment, reduce spares, waste manhours, and reduce the operability of the equipment. See sketch below for fastener installation details:

Recommendation: Make the BACL10T type fastener inactive for Boeing design and monitor all subcontractors to assure that this type fastener is not used. In lieu of the BACL10T type fastener select a quarter turn quick release winged head fastener.

A retrofit for existing cover dividers is in order. One method would be to replace the BACL10T type fastener with a quarter turn quick release winged head fastener. Another more economical method would be to drill a through hole in both the cover divider and cover lip, and install a small quick release pin retained to the divider with a head chain. If required more than one quick release pin may be specified.
